CARGILL RESERVOIR DAM

PHASE I INSPECTION REPORT

NATIONAL DAM SAFETY PROGRAM

NY 00086

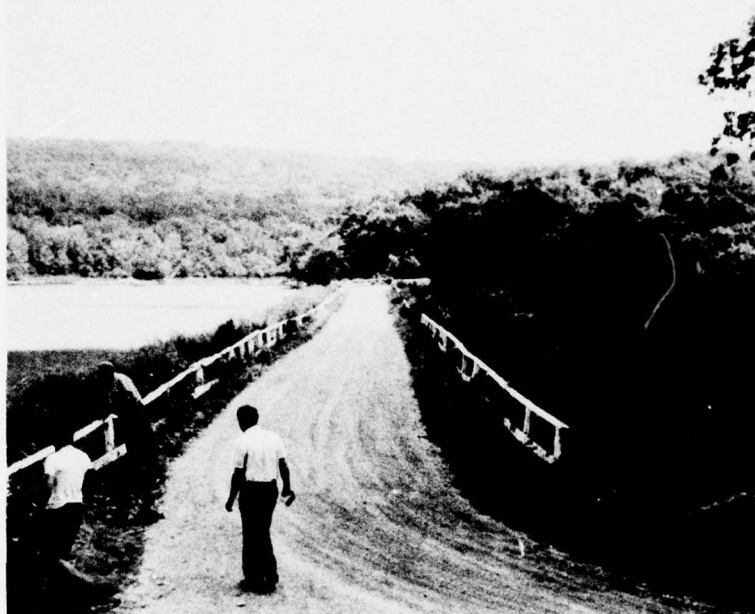
OVERALL VIEW OF DAM

Cargill Reservoir Dam (formerly Beacon Reservoir Dam) is an earth embankment with concrete corewall, and is approximately 650 feet long and 75 feet high at its maximum section. An ungated ogee spillway is located at the south abutment.

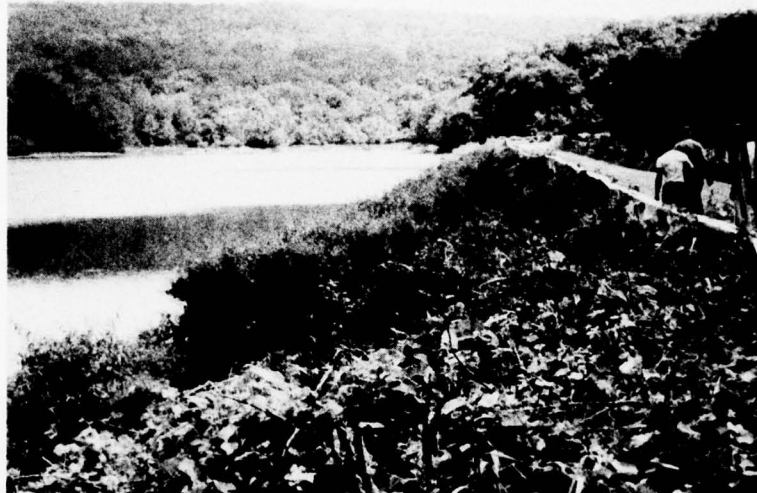
UPSTREAM SLOPE

b. Dam - The upstream slope is covered with brush, as well as a large number of twigs and branches, apparently the result of previous cutting operations. Inspection of the riprap revealed no evidence of displacement or erosion of the cobble-size stones. A wooden fence has been constructed on top of a concrete wall which may be an extension of the corewall. The crest of the embankment is depressed for a distance of about 30 feet north and south of the valve chamber. The downstream slope is heavily overgrown with brush and trees as tall as 35 feet. The exact location of the toe of the downstream slope could not be determined during the inspection since the vegetation growing on the downstream slope is indistinguishable from the forest surrounding the reservoir; the visible topsoil on the embankment matches the overburden on the valley slopes. Areas of flow were evident near the center of the stream valley in the vicinity of the downstream toe. These may be springs or seepage drains that are not shown on the plans. An orange-brown stain on the ground surface and a flow measuring weir is evident at each area. Clear water is discharging from a partially buried pipe near the supposed location of the downstream toe near the center of the dam.

The upstream and downstream slopes are overgrown with trees, brush and vegetation. The roots of the large trees on the slopes may be providing seepage paths which could lead to future piping. These trees could be uprooted by high winds removing large amounts of material from the embankment.

5.2 RECOMMENDATIONS/REMEDIAL MEASURES - The trees and brush growing on the embankment slopes should be cut to root level and removed from the surface of the structure. A further investigation should be made to determine the extent of the root systems before remedial measures can be recommended. After removal of the trees, additional inspections should be conducted to determine the source of seepage and discoloration noted near the downstream toe. The need for a subsurface exploration program, including piezometer installations, should be assessed at that time.

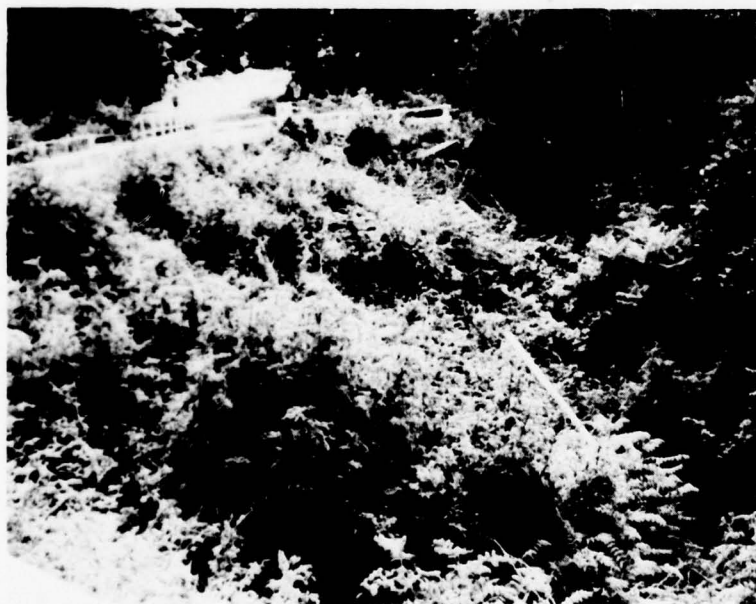
DOWNSTREAM SLOPE

The seepage condition at the downstream toe, which may be associated with the depression, has been in existence since 1932 according to correspondence between State and Local Officials. The letters contain information describing weirs constructed to measure the seepage, the depth of flow over the weirs and the "brown precipitate" collected on the bottom of the collection basins.

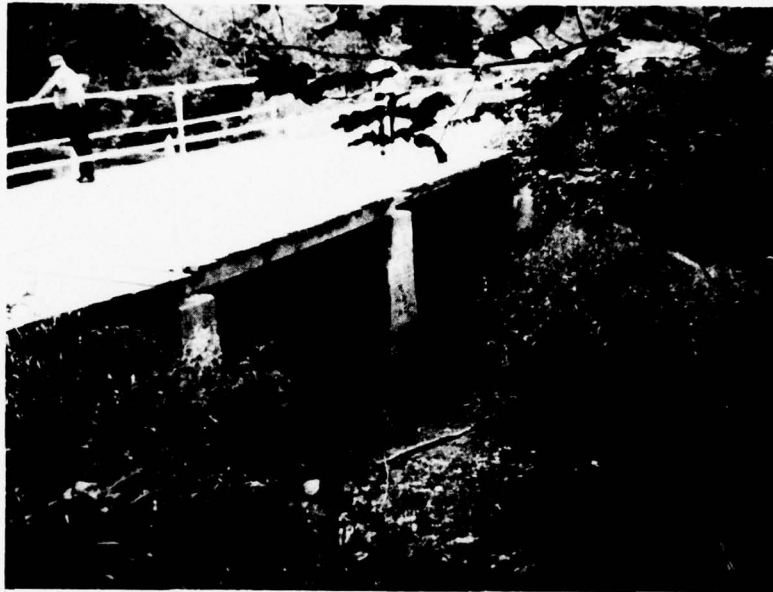
BRIDGE OVER SPILLWAY APPROACH

The spillway approach channel is partially clogged with brush and debris. The concrete wingwalls, bridge pier and ogee weir appear to be in good condition. The weir is constructed about 25 feet downstream of the bridge and extends from the training wall to the south abutment. The weir is approximately 5 feet high at the maximum section, with a base width of approximately 8 feet. This spillway configuration is not as shown on the original contract drawings. There is no well-defined outlet channel downstream of the spillway crest. The concrete training wall protecting the embankment from the spillway flow is in fair condition.

VISUAL EXAMINATION OF	OBSERVATIONS	REMARKS OR RECOMMENDATIONS
CONCRETE WEIR	No problems noted	None
APPROACH CHANNEL	The spillway approach is partially clogged with brush and debris.	This debris should be removed to avoid clogging of the bridge openings.
DISCHARGE CHANNEL A5	The south valley slope acts as the discharge channel; flow is guided downstream away from the embankment toe by a 180 foot long x 4 foot high concrete training wall.	Portions of the channel should be excavated to provide sufficient capacity to prevent overtopping at the training wall.
BRIDGE AND PIERS	A wooden bridge spans the spillway approach channel on two concrete piers. The concrete piers and bridge abutments are in good condition.	None
